Water Damage/Mold Investigation

**Tewksbury Senior Center
175 Chandler Street
Tewksbury, Massachusetts**

Prepared by:
Massachusetts Department of Public Health
Center of Environmental Health
Emergency Response/Indoor Air Quality Program
January 2007

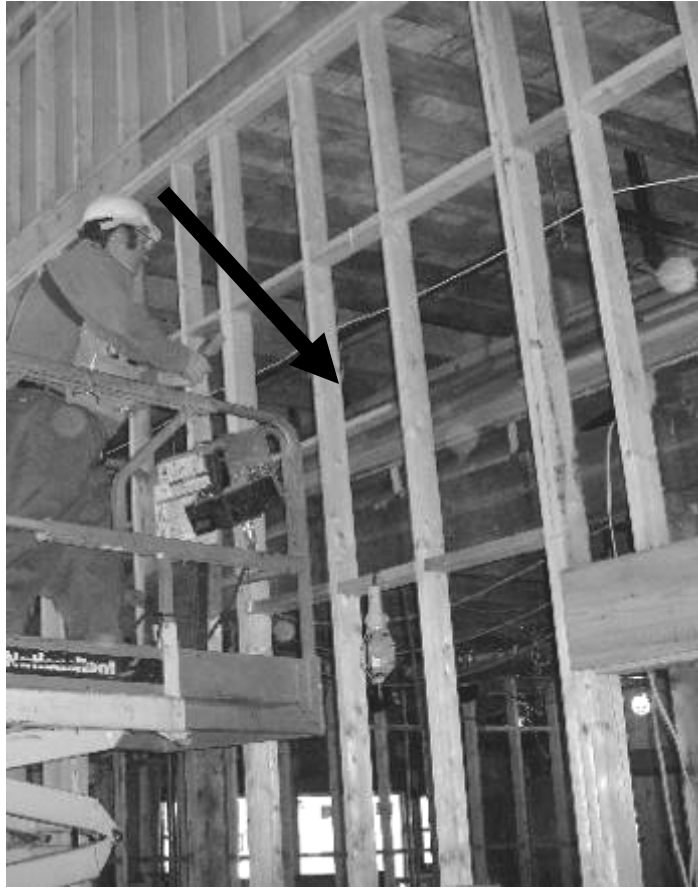
Picture 1

The TSC is a one-story wood frame structure built in the 1980s-1990s. As part of the renovations, a new addition is being constructed at the rear of the building. The new addition encloses parts of the original building's roof. The original roofing material was covered with plywood, upon which part of the new addition roof support rests (Picture 1).

New Addition Included the Construction of an Addition, Which Encloses Parts of the Original Building's Roof (Arrow) inside the New Wing

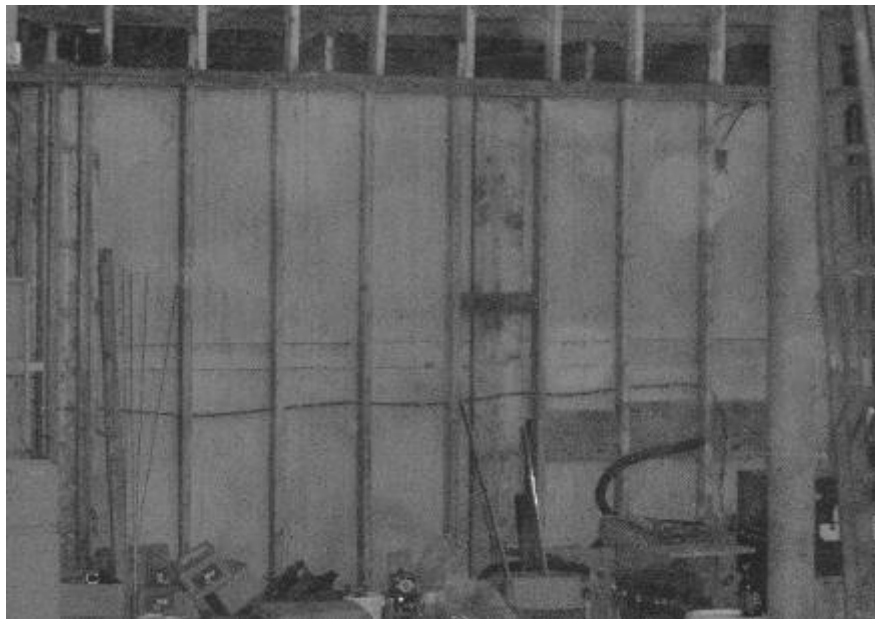
Picture 2

As reported by Tewksbury officials, water penetration through a variety of openings in the original building/new addition junction is the likely source that moistened building materials (i.e., portions of the original building's roof, gypsum wallboard) (Picture 2). The edge of the original buildings roof appeared to be degraded from water exposure (Picture 3).

Existing Restroom Walls below Water Exposed Roof Materials

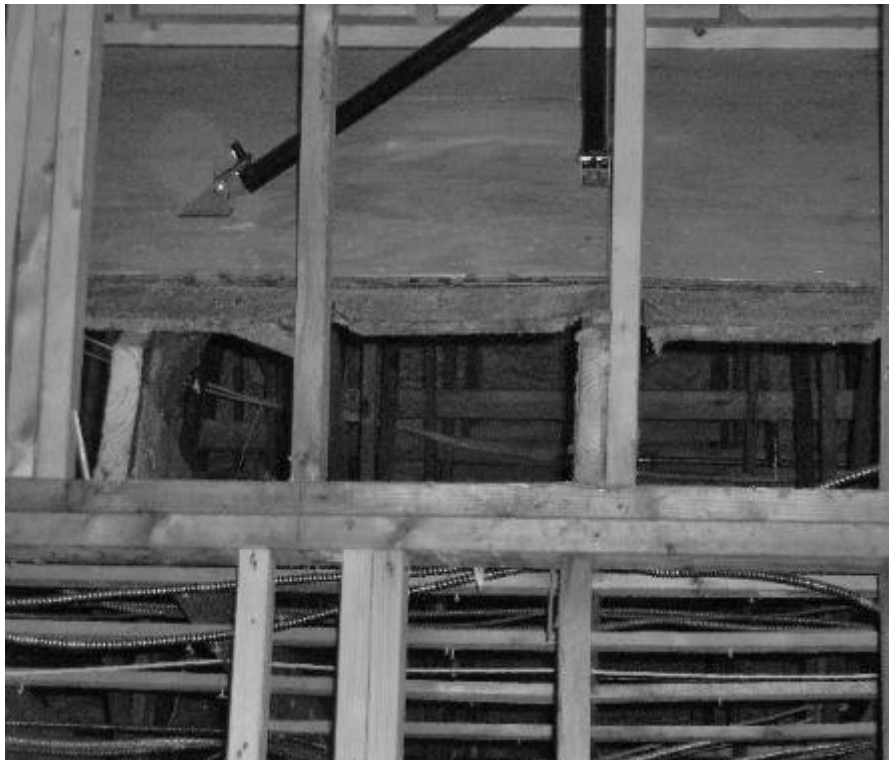
Picture 3

Original Buildings Roof Materials Appeared to Be Degraded from Water Exposure

1. Remove all GW that shows signs of water damage or mold colonization, since these materials cannot be adequately disinfected.
2. Remove GW in both existing restroom walls to a height of approximately 1-foot above the floor to remove water damaged materials.
3. Remove the degraded section of the original roof. Consider sealing the edge of these materials with an appropriate water sealing compound.

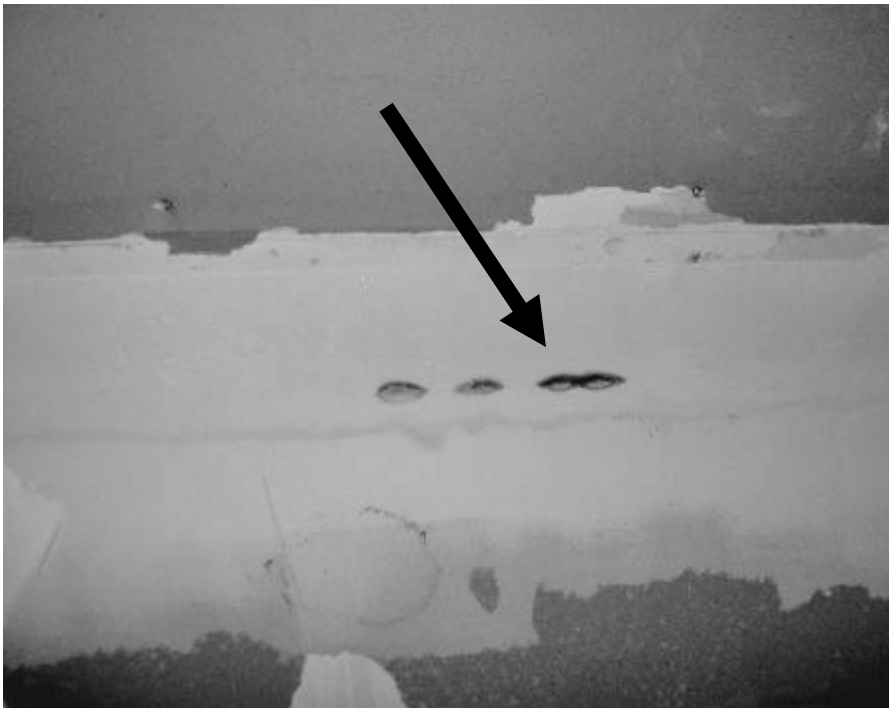
Picture 4

Normal moisture levels (non-detectable-8.8 %) were measured in all wood roofing materials tested. These measurements indicate that the materials were dry and not likely to support mold growth. No visible mold growth was observed on the original roof/plywood covering at the time of the assessment. GW also had moisture measurements indicating that the materials were dry (< 5 %). However, visible mold growth was observed on the wall immediately beneath the original building's roof edge (Picture 4) and beneath wall coving in the restrooms (Picture 5).

Mold Colonies in Restroom Wall GW

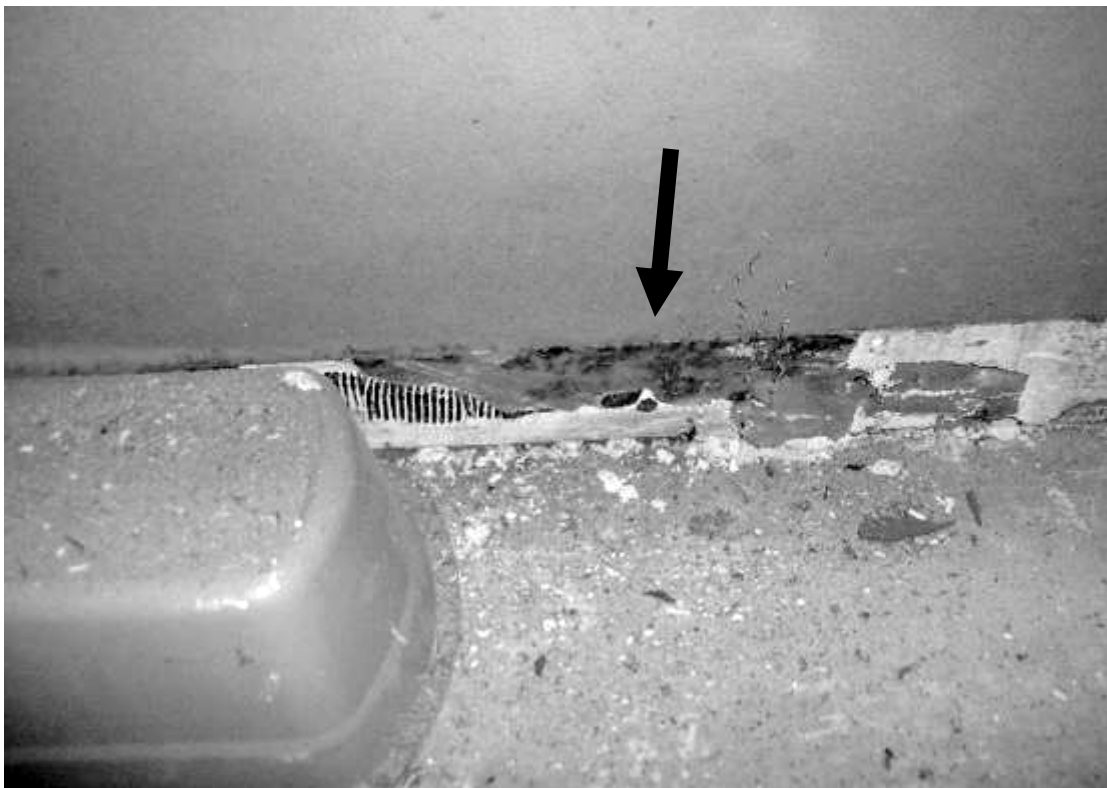
Picture 5

Mold Colonized GW beneath Wall Coving
